Automotive Hydraulic Brake Tube: The Case For 90-10 Copper-Nickel Tubing.

Copper-Nickel Automotive Vehicle Brake Tubing

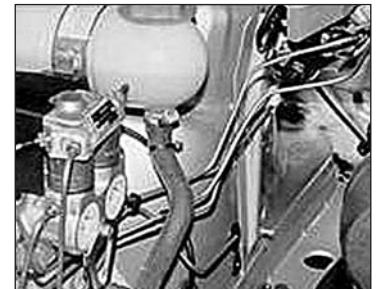
Efforts to achieve a metallurgical solution to the corrosion problem continued. Volvo began the use of 90-10 copper-nickel (“Cunifer Alloy”) tube in their 1976 model vehicles and have been using it since. **Figure 1** shows the installation at the master cylinder in a 1990 model Volvo. Audi began using this material in 1990. The other European cars using this material are Porsche and Aston Martin.²

Figure 1. Copper-nickel brake lines running from master cylinder in 1990 Volvo.

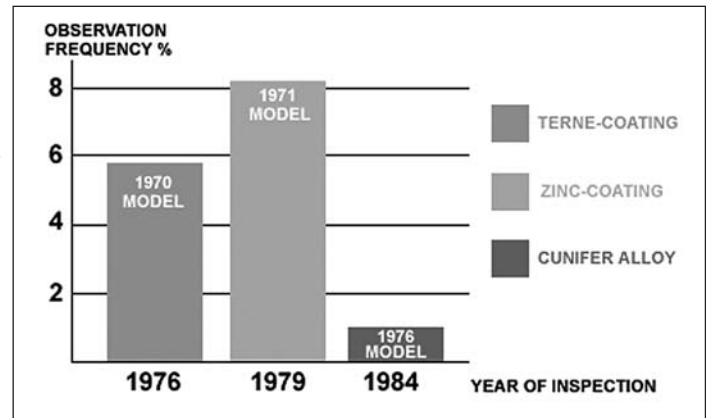
Figure 2.

Annual Swedish Vehicles Safety Inspection Results. The bars indicate the percentage of 8-year old Volvo passenger cars inspected in the indicated year with brake lines which did not meet the inspection requirements. 1976 was the year Volvo introduced 90-10 copper-nickel tubes ('Cunifer Alloy') into their vehicles.

The bar graph shown in **Figure 2** depicts the percentage of vehicles failing safety inspections because of defects in the brake systems of eight-year-old Volvo passenger cars. The 1970 model cars had terne-coated steel tubes. Tubes in the 1971 models were zinc coated. Defects other than rusted tubes are included in these values, but their effect on the data is minimal. The reduction in defects related to the introduction of 90-10 copper-nickel tube in 1976 is dramatic.

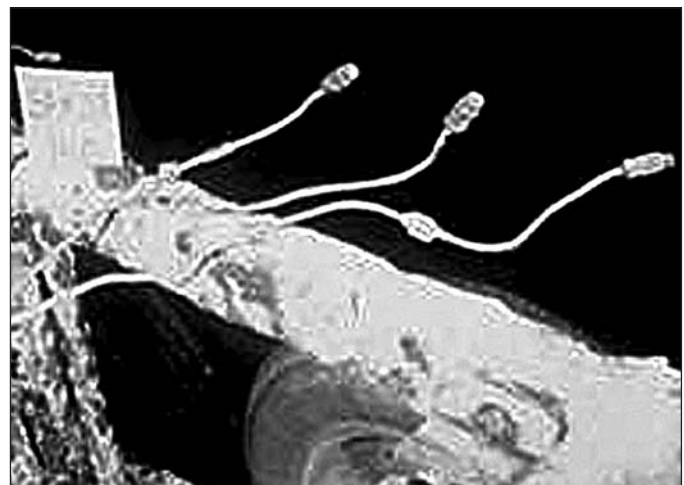
Figure 3. Brake line samples attached to test trailer.

The tube size used for the test was 4.76 mm (0.1875 in.) outside diameter, 0.7 mm (0.028 in.) wall thickness. It was fabricated into typical brake system configurations with flares and tube nuts. The ends were encapsulated to allow subsequent pressure testing. These test specimens were then attached to various areas of the test trailer to assure exposure to all test elements at various degrees of intensity.

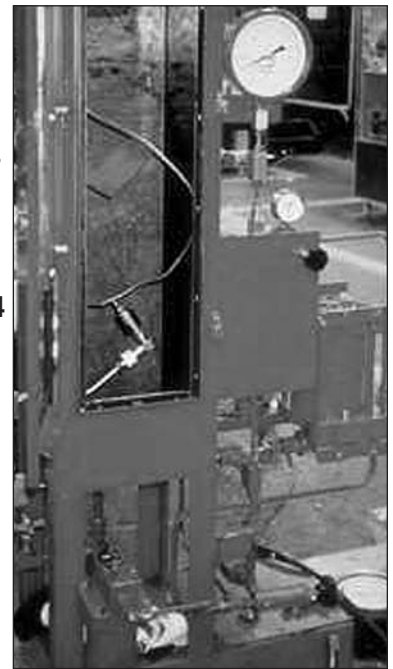
Beginning with the 40th cycle, and at 1 0-cycle intervals thereafter, each tube is subjected to an internal pressure test of 20,684 kPa (3000 psi). Candidate materials must complete 60 cycles to satisfy the minimum requirement. **Figure 4** shows the test equipment on which the hydrostatic pressure tests were made.

Figure 4. Equipment used to test hydrostatic pressure in brake tube.

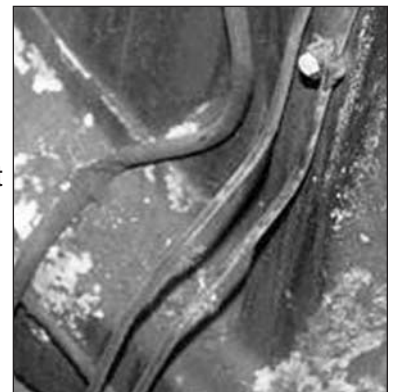
Figure 5 shows the engine compartment of a 1976 model Volvo four-door sedan. The vehicle was located in the storage yard of a used automobile parts dealer. The engine had already been removed and the actual mileage is not known. However, using the corrosion in the engine compartment as a criterion, it can be concluded that the uncorroded copper-nickel brake tubes which can be seen exiting from the master cylinder had, indeed, survived a hostile, corrosive environment.

Figure 5. Engine compartment of 1976 Volvo showing uncorroded copper-nickel brake lines.

The brake tubes were removed from this vehicle and hydrostatic burst tested with the following results:

Tube No. 1	111,694.95 kPa	(1 6,200 psi)
Tube No. 2	106,868.62 kPa	(1 5,500 psi)
